**Steel
TIPS**

May 2007

***Progressive Collapse Prevention
of Steel Frames
with Shear Connections***

Abolhassan Astaneh-Asl, Ph.D., P.E.

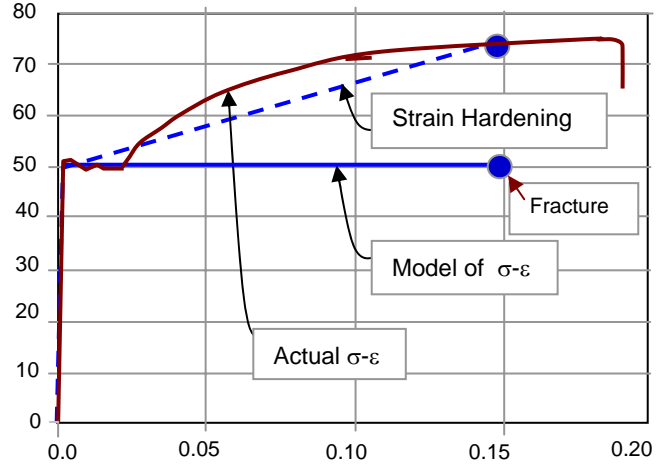
Figure 2.4. Actual and Simplified Stress-Strain Relationship for Steel

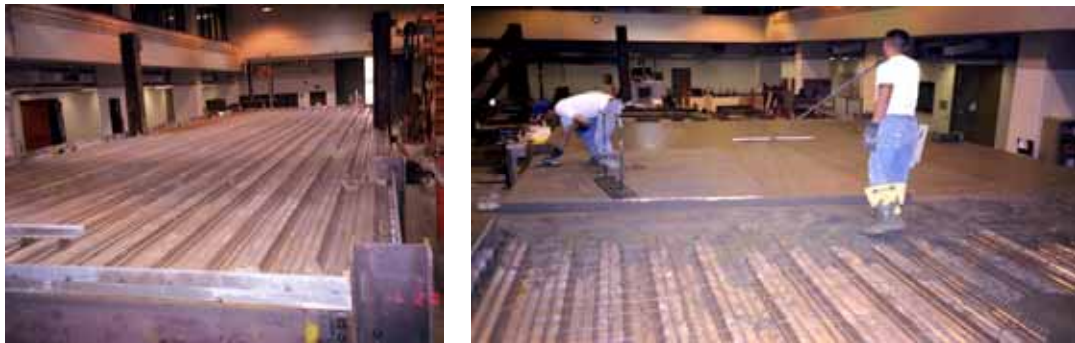
Figure 3.6. View of the specimen prior to and during placing concrete

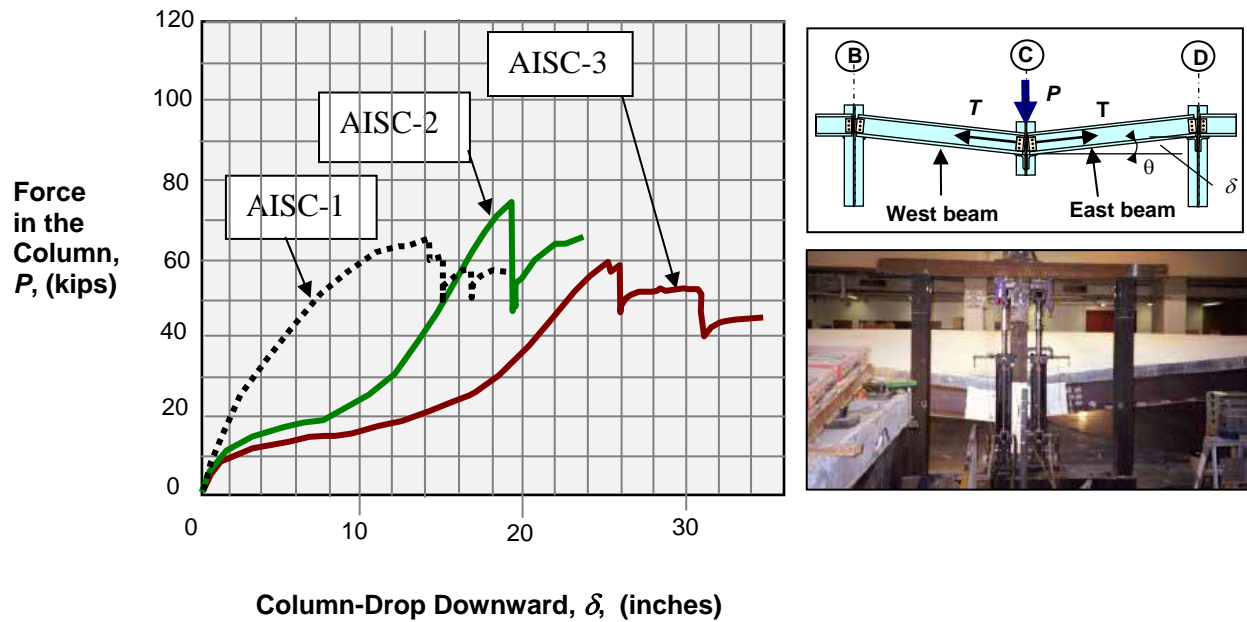
Figure 3.9. Load versus Downward Displacement of Column C2 for AISC Tests

The variations of force in the column that was collapsing (that is Column C2 in Figure 3.3) versus the vertical drop of the column are shown in Figure 3.9.

The force-displacement plot (Figure 3.9) shows a gradual stiffening of the structure once the displacement had passed 5 inches, which is due to the replacement of the two bolts in the seated connection at the drop column. The $\frac{1}{4}$ -inch gap that had remained after the replacement affected the behavior of the structure. As the bolts adjusted to the gap and engaged themselves, the structure became stiffer.

The third test was conducted by pushing the column down 35 inches. The force displacement curve can be seen in Figure 3.9. In addition to the above noted behavior, as the column displacement approached 26 inches, complete failure occurred on the connecting angle between the drop column C2 and the longitudinal beam directly east. After the angle had failed, the concrete slab was the primary element transferring the applied force to the longitudinal beam directly east of the displacing column. Unable to maintain this force transfer, the slab failed in shear along the transverse beam connecting the two columns C1 and C2. Figure 3.15 shows hair cracks as well as major cracks on the top surface of the floor slab at the end of this test. Figure 3.16 shows views of the specimen at the end of Test AISC-3.

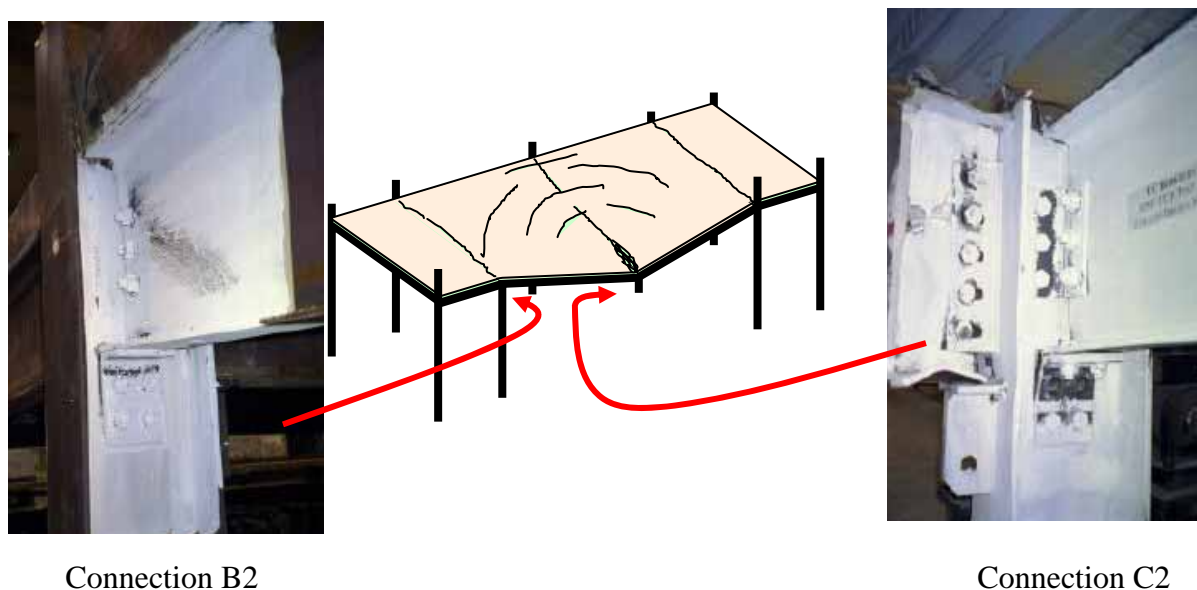
Figure 3.13. View of Two Connections at the End of Test AISC-2 (Column Drop of 24 Inches)

Figure 3.13 shows the connection of the column of the test specimen after Test AISC-2 (maximum column drop of 24 inches). Figure 3.14 shows other views of the specimen after this test.

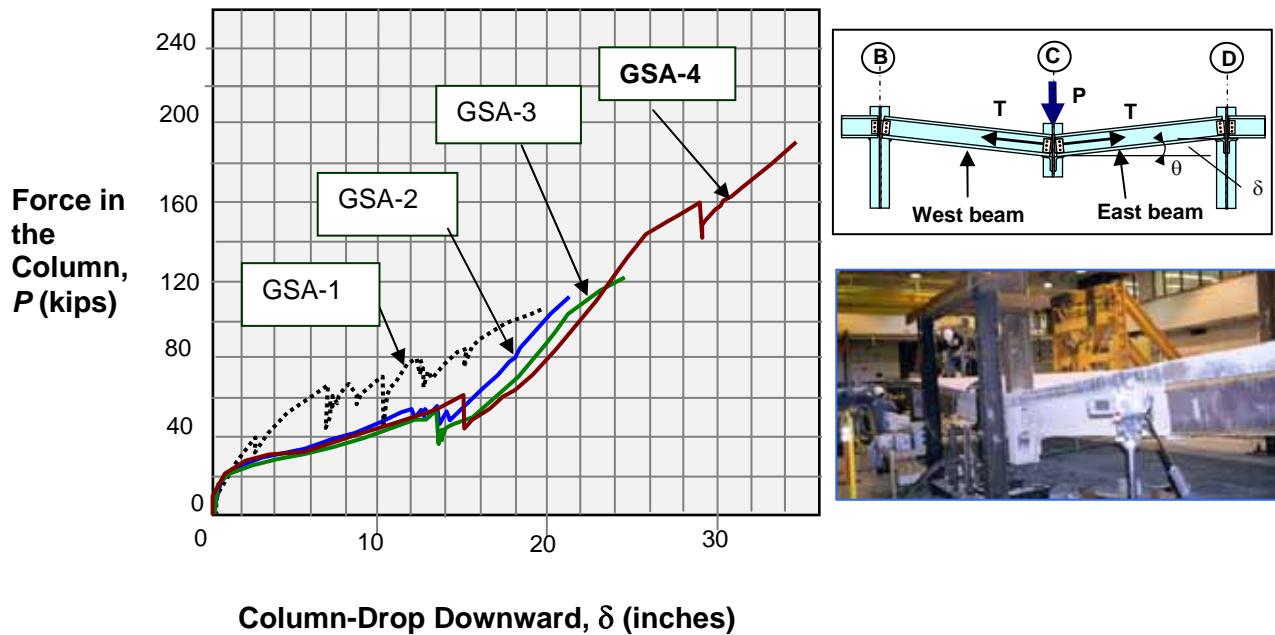
Figure 4.6. Load versus Downward Displacement of Column C1 for GSA Tests

The final report of the project by Astaneh-Asl et al. (2001a) presents a complete result of the tests. Table 4.1 provides a brief summary of the highlights of the test results and the significant behavior during the tests. Figure 4.6 shows load versus displacement for Column C1 for the four tests.

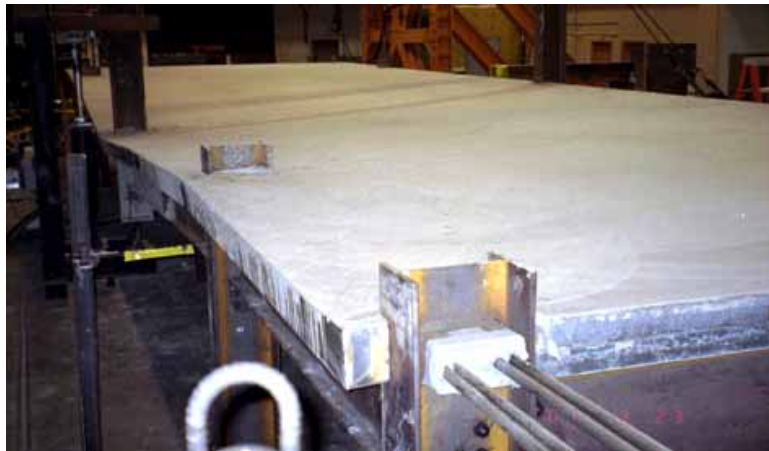
Figure 4.7. Displacement of Drop Column, Test GSA-1

Figure 4.7 shows a typical view of the specimen at the end of Tests GSA-1, 2, 3, and 4 when the vertical displacement of the drop column was 20, 21, 24, and 35 inches respectively. Table 4.1 summarizes the behavior of the specimen in all four tests.

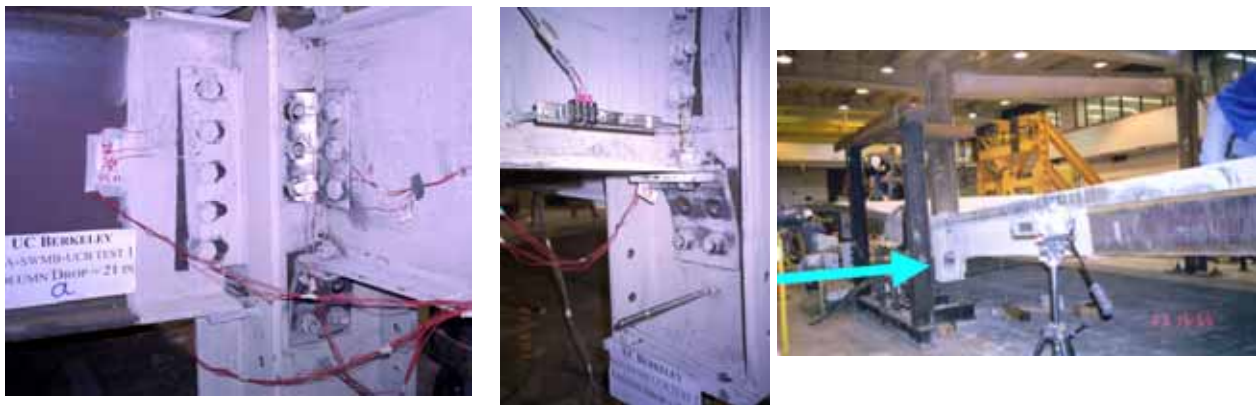
Figure 4.10. Loss of Two Bolts on the Seat Angle, Deformation of a Single Angle on the Web, and Free Rotation of the Beam in Slotted Holes

The drop column for this test was column C1, Figure 4.2. No noticeable damage or deformations to the structure was observed during the test with the exception of the damage of the transverse beam on axis C as well as the two beams on axis 1, all three beams connected to the drop column. The connections of these beams also sustained damage during the test. No deformation was noticed in the column itself, though the areas behind the angles, where the bolts attached, were not visible and the potential for yielding was much more likely there. Figure 4.10 shows a view of the connection at location C1. Clearly the transverse beams on the left has rotated freely by bolts moving inside the long slots intentionally designed to allow a rotation of about 0.15 radians at the end of the transverse beam. At the connection to the transverse beam, the bolts had slid along the slots in the shear tab. The shear tab itself had undergone slight deformations, if any, while the transverse beam had buckled slightly around the beam seat. The web of the transverse beam also showed some yielding near the base of the shear tab. This yielding was not as noticeable on the other side of the girder. The horizontal edge distance of the shear tab showed signs of deformation and initiation of failure, as can be seen in Figure 4.10.

The single angle bolted to the web of the beams in the east- west direction and bolted to the web of drop column C1 underwent large inelastic deformations as shown in Figure 4.10. The center of the angle was very shiny. That area was previously ground down for strain gauging,

which was now exposed as it yielded and the whitewash flaked off. Yielding was also clear at the base of the angle and on the longitudinal beam it was attached to. The bottom seat angles attaching the E-W beams to the drop column had deformed away from the column. The angle attached to the web also had pulled away from C1, as the bare face of the column web was exposed from behind it in Figure 4.10. The beam seat had managed to stay connected to the longitudinal beam through its two vertical bolts; however, of the four horizontal bolts connecting the longitudinal beam seats to the column, the top two bolts had failed as shown in Figure 4.10. The end connection of the east longitudinal beam at the location of column B2 showed a crescent-shaped buckling of the web as shown in Figure 4.11. The buckling of the web was related to the rotational restraint provided to the end of the beam by bolts connecting the bottom flange of the beam to the horizontal leg of the seat angle.

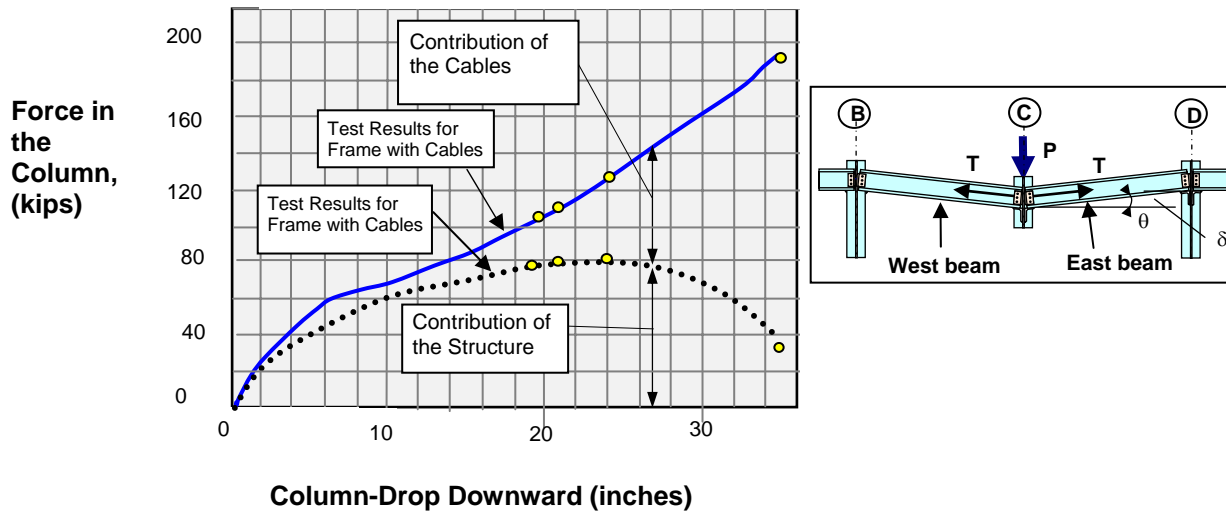
Figure 4.16. Total Load for the Frames with and without Cables

2. Figure 4.16 shows the envelope of the load-displacement curves for the north frame, which had the catenary cables, and the south side frame, which did not. The steel frames on the north and south side of the specimen were identical except for the steel cables and the reinforcement of the floor slab around the cables, which were present in the north side frame only. The testing of the south side frame and its behavior were discussed in Chapter 2. Figure 4.17 shows the contribution of the cables and the structure to the overall strength and stiffness of the system. Initially, up to a column load of about 60 kips corresponding to a drop of about 10 inches, the resistance to the column drop primarily was provided by the structure itself. Beyond this point, when the top two bolts of the seat angle supports fractured, some of the resistance to the column load came from the cables as well. As the column load increased, the contribution of the structure

decreased, and the cable carried most of the load. Beyond about 27 inches of column drop, the cable was carrying more than half of the column load, as seen in Figure 4.16.

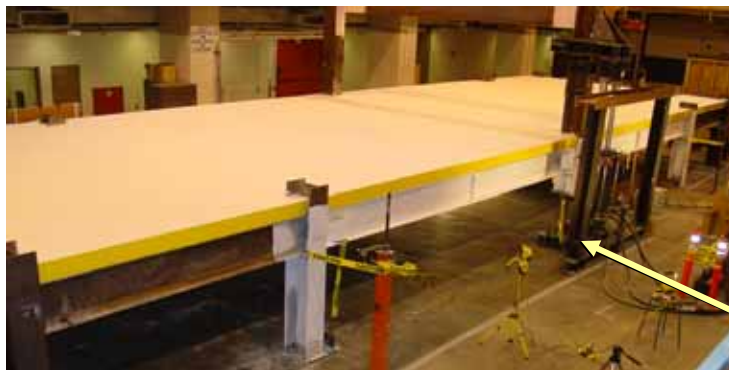
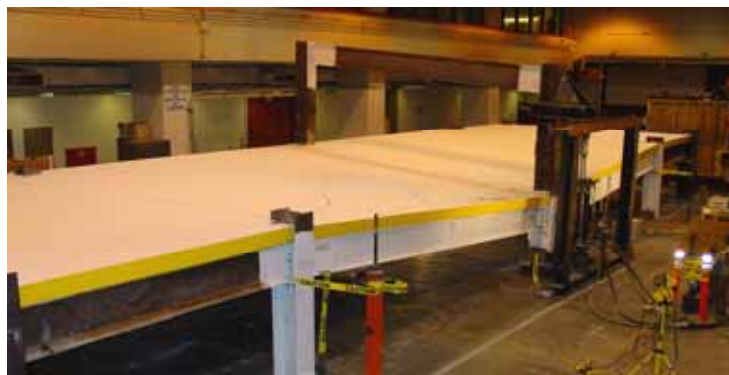
This part of the column was removed at the start of the test.

Figure 5.1. Views of the Specimen without Retrofit before (Top) and during the Test (Bottom)

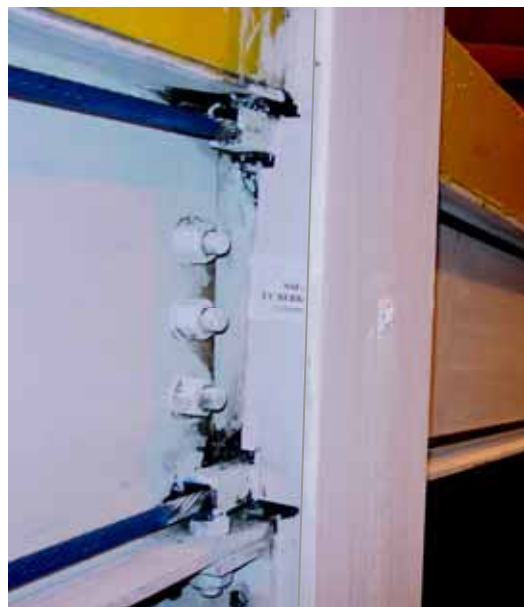
Figure 5.5. Cable Sleeves at Drop Column

The cables were protected from damage in areas where they were in contact with sharp steel edges that is in the holes cut in the column web. As the drop column displaced downward, the web of the drop column would bear down on the cables. The cables would in turn develop catenary forces and transfer the load to adjacent columns and the rest of the structure. However, the “knife-edge” of the hole in the column web could damage the cables under the large column loads. To prevent such damage, 6-inch long cable sleeves (consisting of L2x2 angles) were installed around the cables to protect them as they passed through the column webs (Figure 5.5). Angle sleeves were also used on the beams to indirectly connect the retrofit cables to the longitudinal beams on frame line 2 (south façade in Figure 5.2). Figure 5.6 shows a view of the cable sleeves on the beams.

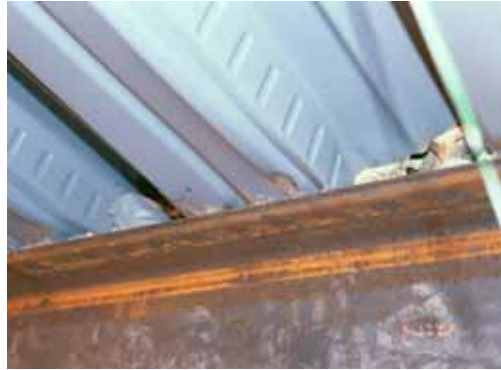
Figure 5.9. Local damage to Steel Deck Above the Top Flange

Obviously, fracture of the shear the tab on the east beam totally eliminated catenary forces developed within the beams in the areas adjacent to the drop column. By observing pre- and post failure behavior, I could conclude that the 1/3 strength that the system showed after fracture of the shear tab must have been due to catenary force developed in the steel deck above the beams providing some measure of continuity between the east and west beams and enabling the system to develop catenary force through this continuous load path. Strains at two points on the bottom surface of the steel deck are given in Table 5.2, and indicate participation of the steel deck in developing and resisting catenary forces, which in turn resulted in providing some resistance to the progressive downward collapse of the drop column. Notice that the yield strength of the deck was specified by the manufacturer as 33 ksi, which results in a yield strain of $33 \text{ ksi}/29,000 = 1137 \times 10^{-6}$. During Test NSF-1, the strain gauge measurements did not exceed this value of yield strain, indicating that there was no widespread yielding of the deck. However, local yielding and local buckling of the steel deck were observed in the areas near the top flange support. Figure 5.9 shows local buckling of the steel deck adjacent to the top flange of the transverse beam.

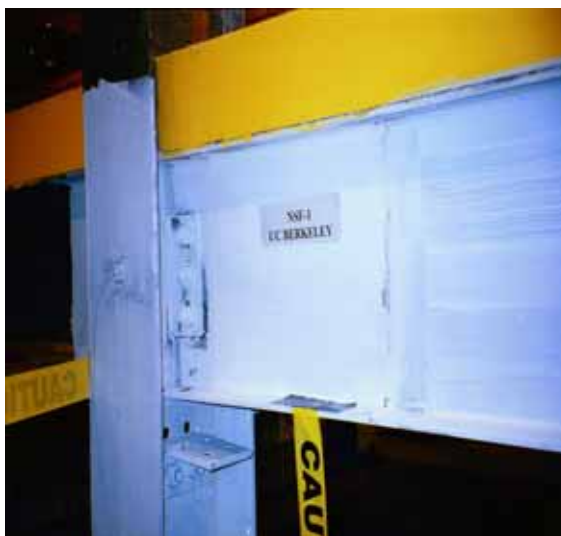
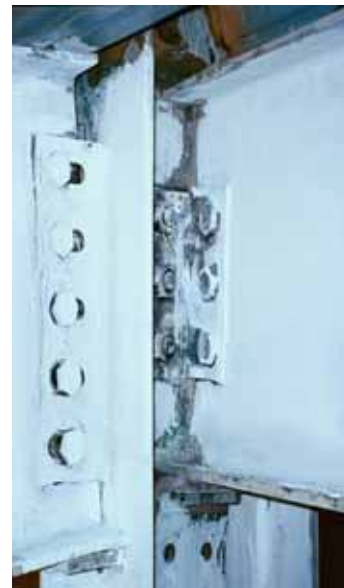
Figure 5.11. Yielding and Deformations without Fracture in the Connections, Test NSF-1
Progressive Collapse Prevention of Steel Frames with Shear Connections

After repairing the fractured weld on the shear tab, the testing continued with no significant event. At prescribed vertical displacement of 22 inches Test NSF-1. was stopped. Figure 5.10 shows the sequence of the drop of the column during the test, and Figure 5.11 shows the yielding and deformations in the connections. Figure 5.12 shows top and side views of the specimen at the end of Test NSF-1.

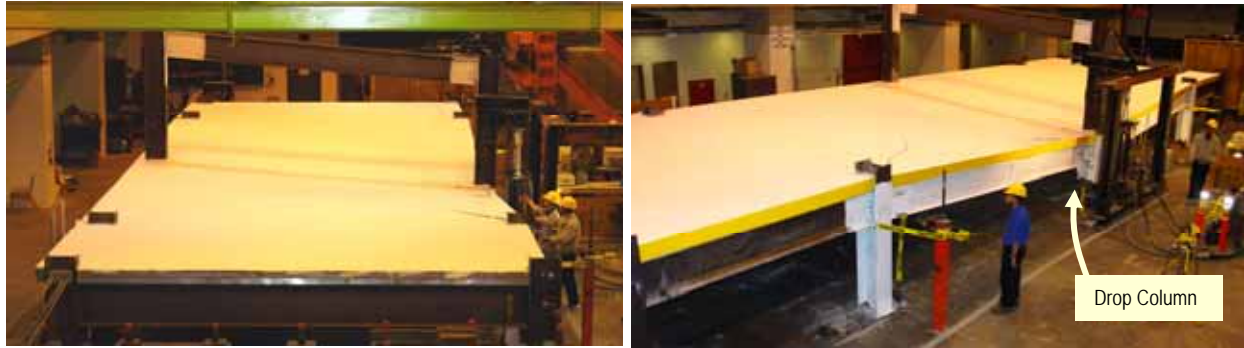
Figure 5.12. Specimen at the End of Test NSF-1

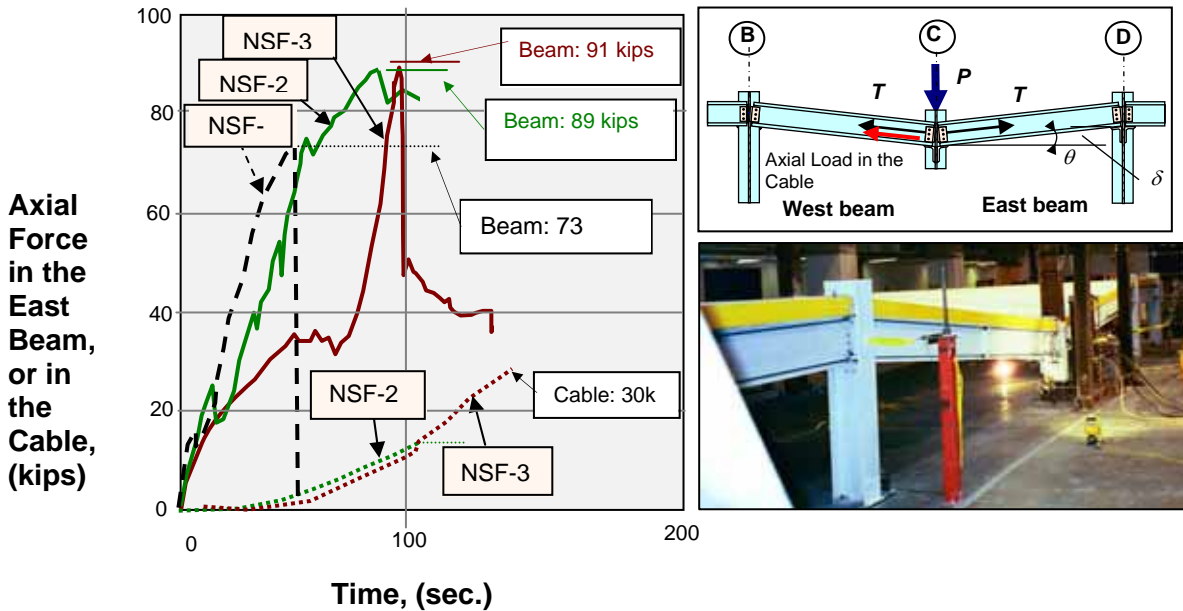
Note: During Test NSF-1, retrofit cables have not been added yet.

Figure 5.15. Axial Forces in the Beam and Lower Cable

Figure 5.15 shows the variation in the axial force of the east beam during the three tests. These axial forces were computed as a product of the average longitudinal (catenary) strain of the beam multiplied by the elastic modulus of steel (29,000 ksi) and the area of the steel beam. As the drop column displacement increased, the axial forces of the beam, due to catenary action, also increased. At the time of fracture of the edge distances of the shear tabs, the axial load in the beam was about 91 kips see Figure 5.15.

In Test NSF-1, the axial force of the beam had reached a maximum of 73 kips. At this point the bolts on the shear tab and the edge distance had slightly deformed. During Test NSF-1, the specimen did not have cables; therefore, no cable forces are plotted on Figure 5.15. In Test NSF-2, the maximum axial force was 89 kips in the beam and 14 kips in the cable. In Test NSF-3, the maximum axial force of the beam was 91 kips and of the cable was 30 kips. When the axial load of the beam reached 91 kips, the three bolts on the shear tab completely came out of their holes by fracturing the edge distance in a “block shear” failure mode, as shown in Figure 5.15. The calculated capacity of the shear tab for this failure mode was 85 kips.

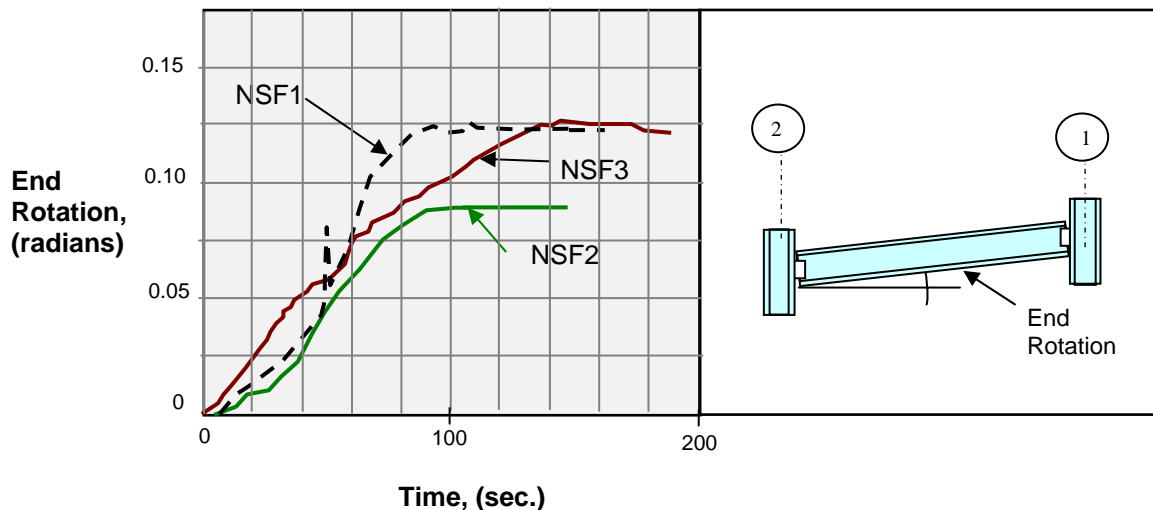
Figure 5.16. Rotation of the Transverse Beam at the South End

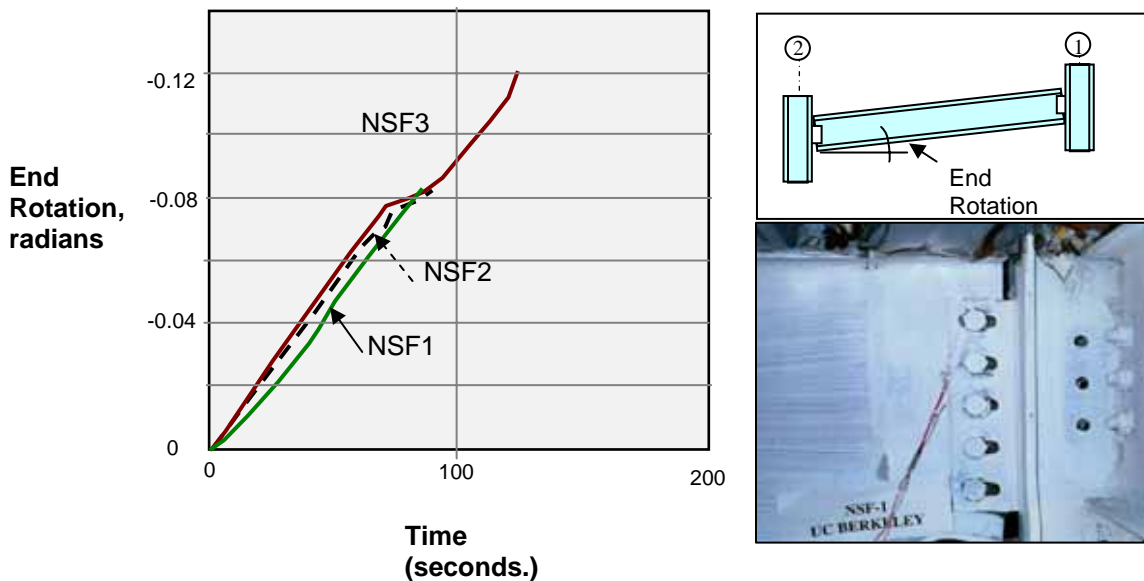
Figure 5.17. End Rotation of the Transverse Beam at the South End (End 2)

Figure 5.17 shows the south end rotation of the transverse beam framed into the drop column in north-south direction. The W21x44 transverse beam had shear tabs with long slotted

holes on both ends. These rotations were computed using data from the displacement transducers mounted on the beam and connected to the drop column. Beam end rotation was computed as the difference of the top and bottom transducer reading divided by the vertical distance between the transducers. The maximum relative rotations at the south end were approximately 0.09, 0.08, and 0.13 radians for Tests NSF-1, NSF-2, and NSF-3, respectively. The maximum relative rotations at the north end were approximately 0.10, 0.10, and 0.14 radians for the three tests, respectively. Assuming that the shear tabs act as perfectly pin connections, the calculated values for these rotations were, 0.11, 0.11 and 0.16 radians. The measured values are about 90% of the calculated values. The difference can be attributed to the contribution of the floor slab to the stiffness and bending strength of the end connections. Since the bolt holes on the shear tabs were long slotted, it appears that this may have caused more rotational flexibility in the end connections, making the measured values only about 10% different than the calculated values.
